## The Challenges of Treating Delaminating Slate Headstones: New Treatments with New Materials

This presentation is part of the [International Cemetery Preservation Summit](#), April 8-10, 2014 Niagara Falls, NY.

### The Challenges of Treating Delaminating Slate Headstones: New Treatments with New Materials by Irving Slavid

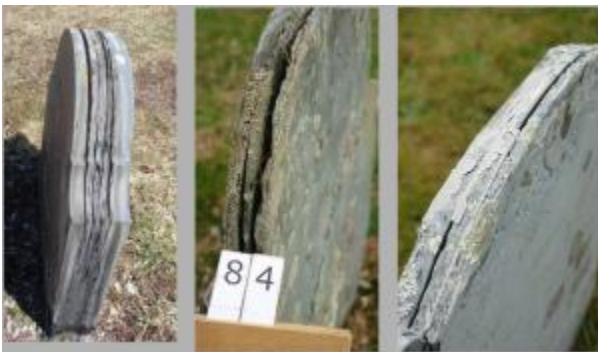
Slates in various states of delamination.

These examples on the left are 3 different kinds of opening up. There's a picture there of an old epoxy in the top, failing. Water's going to get in there. Snow's going to get in there. Ice is going to get in there. Over the course of time, they're going to pop apart, like the one on the right. I think someone mentioned about the heat on the stones is going to cause them to move.

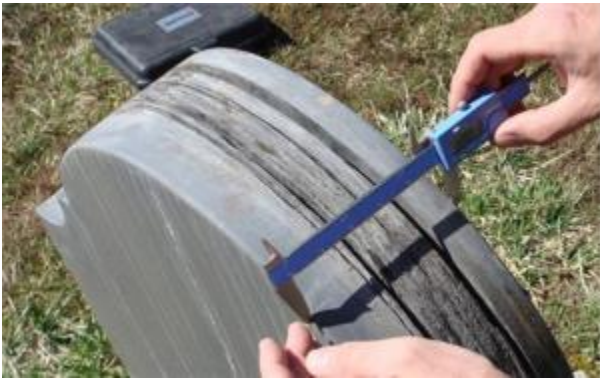
Quite a while ago, we started monitoring ... I had this one big, thick slate with many big delaminations that you can see, which I could monitor the movement on it. On the left-hand side is a digital laser thermometer, which I could record the temperature of the side of the stone in the sun, the side in the shade, the difference in the temperature, and I would monitor how much it moved.

If you look carefully, well don't look carefully, there's little scribe marks on the slate, so I knew where to put the micrometer every day to measure the same distance. It moved. When you have something moving and we want to fill the inside of it with a cementitious material which does not move, you got a problem. We could put it in the granite. We started experimenting with different fills. One of the problems with the cement that we ran into was we found a wonderful product about 12 years ago and then it was taken off the market. It was a flexible epoxy, but epoxies have got their problems.

Measuring the gaps of delamination.

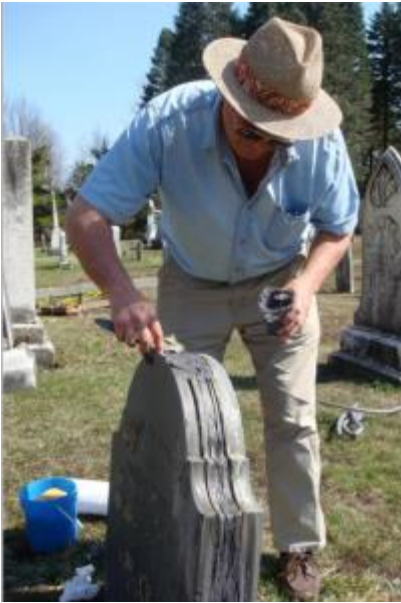
Then you can fill the interior void, which I prefer to do. If someone's going to ask me when do you decide what to do and which stone, I don't have a good answer for that. It's a gut feeling of how big the void is and what's happening. We've gone along ... This is a pourable grout. It's a hydraulic lime grout. It's a very weak strength. It's a fluid one, it actually likes to pour. Hopefully I can show you that. Here I've either got a backer rod all around the edge or sometimes I fill it first to the edges and then I can pour, but I have to contain this liquid.

There I am pouring. If this movie works next, I'll show you. This stuff likes to flow. It likes to move. I've put in quarts or gallons of this material. Oh, wrong way ... Ah, it does work. It just likes to move. It likes to flow down. This is actually a brown sandstone, but I had a better movie than the one I did for the slate. You see it coming out, looks ... Darn, sorry. It won't work again. Okay, this one. You see it coming out here. It's just flowing, flowing, flowing, and going down this crack. It's going all the way down to the bottom of this stone, which is about 3 feet tall. If it leaks out, there's a backer rod. That's what it looks like, plastic. Sometimes I like to see it leak out of the bottom. I know it's gone all the way, and then I can fill it up.

Irving Slavid applies a fill to a delaminated slate.
