48 PRESERVATION BRIEFS

Preserving Grave Markers in Historic Cemeteries

National Park Service
U.S. Department of the Interior

Technical Preservation Services

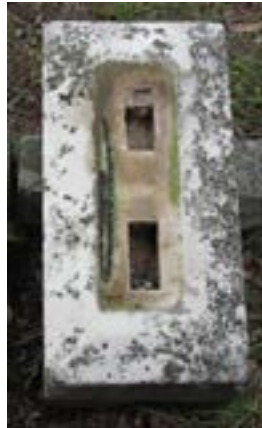
Figure 3. A multi-element grave marker from the early 19th century in the St. Michael’s Cemetery, Pensacola, FL, consists of a vertical element with tabs (left image) into a slotted base (right image). Photo: Fran Gale.

slot” grave marker, the tabbed upper stone was set in a slotted base (Fig. 3). More common today, the upper headstone is secured with a technique that uses small spacers set on the base and a setting compound. This technique or one that uses an epoxy adhesive may be found on older markers where the stones have been reset.

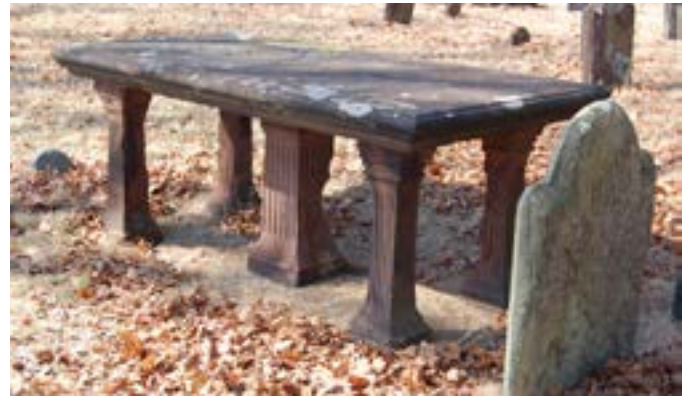
Figure 4. This sandstone table tomb, located in Cedar Grove Cemetery, New London, CT, is an engineered grave marker structure consisting of a horizontal stone tablet supported by four vertical table “legs” with and a central column,. Photo: Jason Church.

Grave markers can also be engineered structures. Examples of grave marker structures include masonry arches, box tombs, table tombs, grave shelters, and mausoleums (Fig. 4). The box tomb is a rectangular structure built over the gravesite. The human remains are not located in the box itself as some believe, but

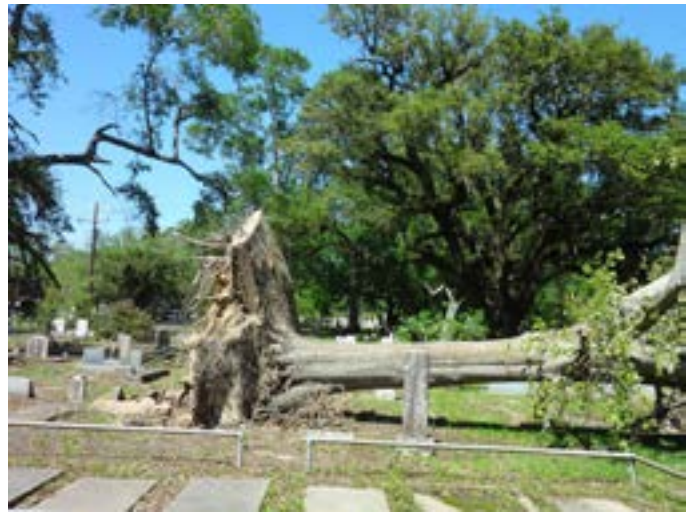
Figure 11. Woody vegetation can damage grave markers and pose a risk to visitors unless well managed and maintained. Photo: Jason Church.

Woody vegetation can damage grave markers in a variety of ways (Fig. 11). Trees, bushes, and vines can shade grave markers, extending the time that the markers are exposed to moisture. Tendrils and roots may burrow into mortar joints and openings, causing mechanical damage and large plants may lift up or shift markers. Even leaves and twigs, when allowed to collect on the ground near grave markers, can affect water drainage and evaporation (Fig. 12).

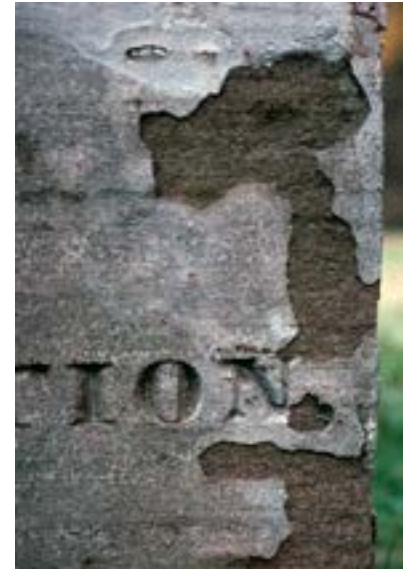
Figure 13. The impervious coating used to "protect" this sandstone grave marker trapped moisture within the stone, eventually resulting in deterioration and surface loss. Photo: Fran Gale.

Repointing masonry grave markers using Portland cement mortars that are harder than historic mortars often results in accelerated deterioration of the masonry material. Mortar should be softer than the adjacent masonry, enabling trapped moisture to migrate out, and serve as the sacrificial material when cracking occurs to relieve excessive stress. Problems also result when using impervious "protective" coatings that can trap moisture within the masonry, resulting in damage during wet/dry and freeze/thaw cycles (Fig. 13).

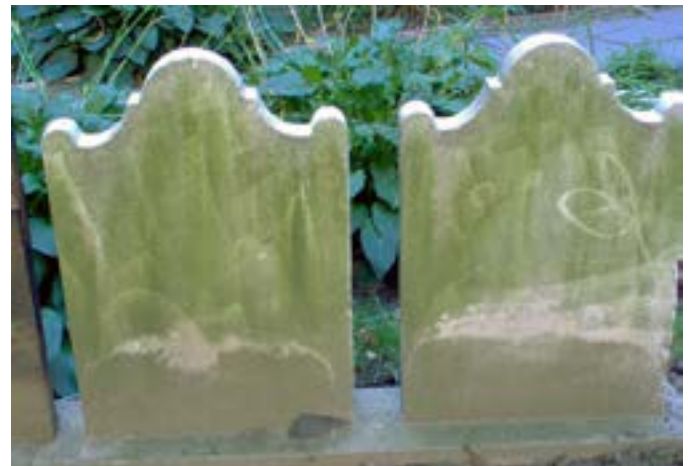
Figure 14. High-pressure water washing can damage grave markers. The photograph shows "wand marks" on the headstones produced by inappropriate pressure washing. Photo: Jason Church.

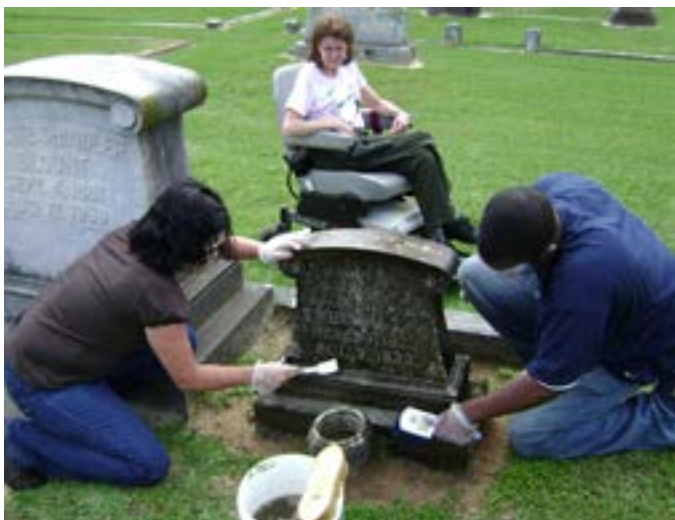
Figure 17. Volunteers can undertake cleaning of grave markers once they have received initial training. Cleaning methods may include wetting the stone, using a mild chemical cleaner, gently agitating the surface with a soft bristle brush, and thoroughly rinsing the marker with clean water. Photo: Jason Church.

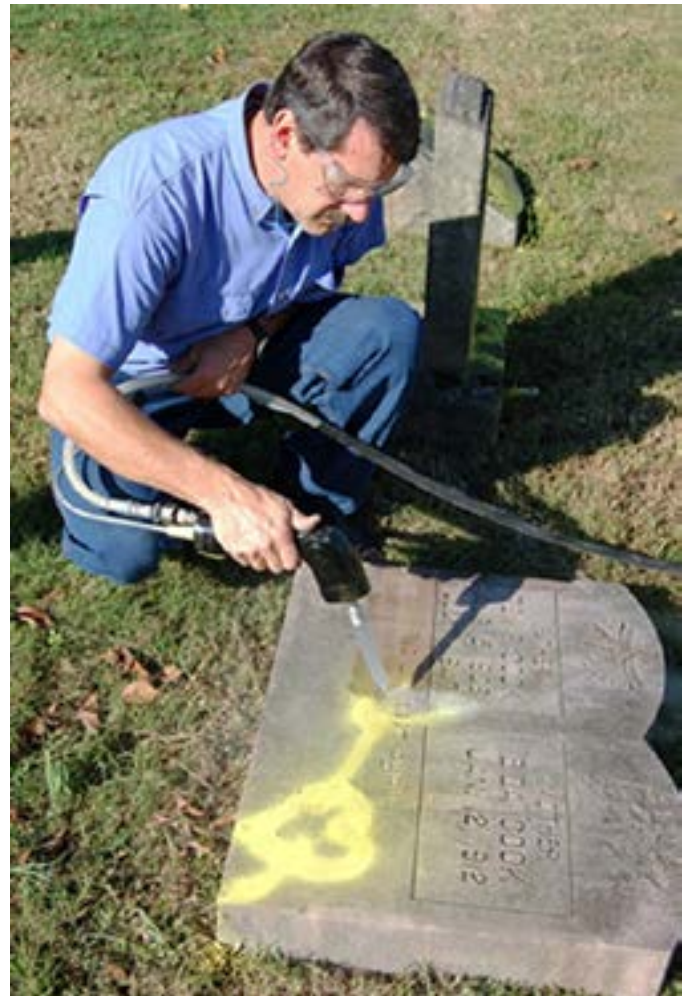
Figure 18. Graffiti is carefully removed using a low-pressure dry-ice misting instrument. Photo: Jason Church.

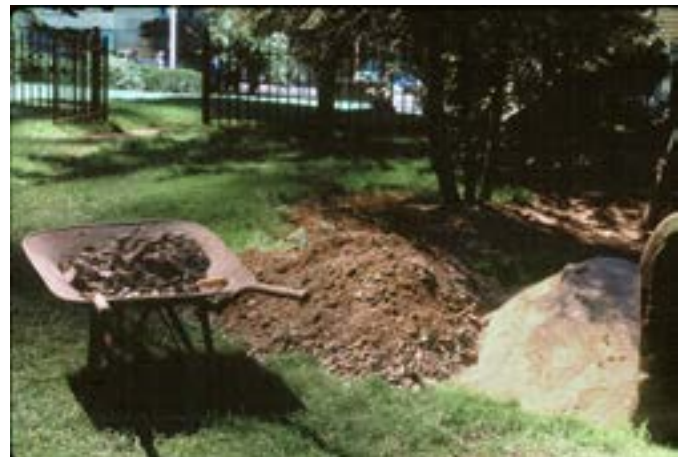
Figure 20b. To facilitate drainage, crushed stone, gravel, and sharp sand line the hole and are hand-tamped around the stone after placement. Photo: Fran Gale.

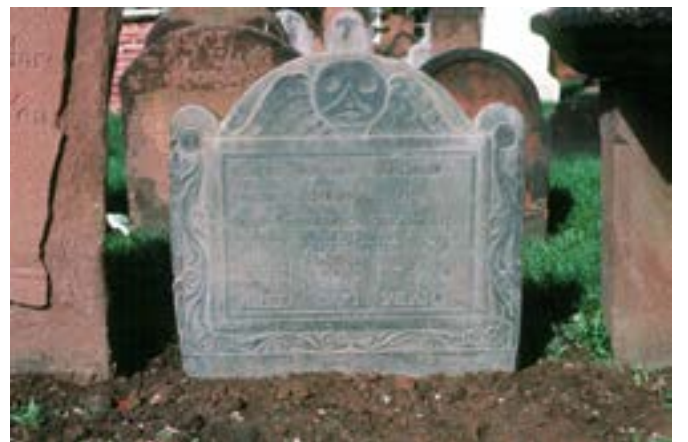
Figure 20c. The reset ground-supported grave marker should be level and plumb. Photo: Fran Gale.
