Portland Cement Vs Historic Gravestones

This presentation is part of the [International Cemetery Preservation Summit](#), April 8-10, 2014 Niagara Falls, NY.

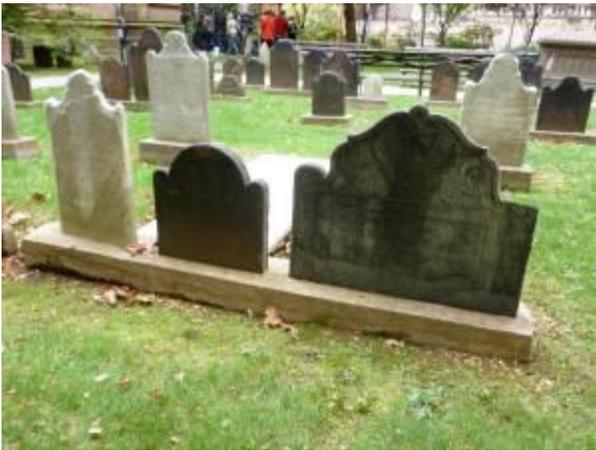
Problems with concrete cast around historic stones.

What you'll find often sometimes, is they actually cap the existing bases. I have some latter pictures of that as well, but you can see here the ... Let me see if I can work this, okay there we go. You can see what happens when you embed this marble around the concrete is that it's pretty, really crumbling. Just disintegrating like granular disintegration, sugaring. That's what will tend to happen if you combine these unlike materials.

You can see concrete on one side. This is in Trinity Churchyard in New York City, in Manhattan. That is concrete, three stones. They formed it and it's above ground, but it's still three stones put into one mass of concrete. This is in Hampton, New Hampshire. They get carried away. If you can do a couple why not do a whole cemetery. This is in South Salem, New York; just a couple good close-ups here. This is something that I worked on.

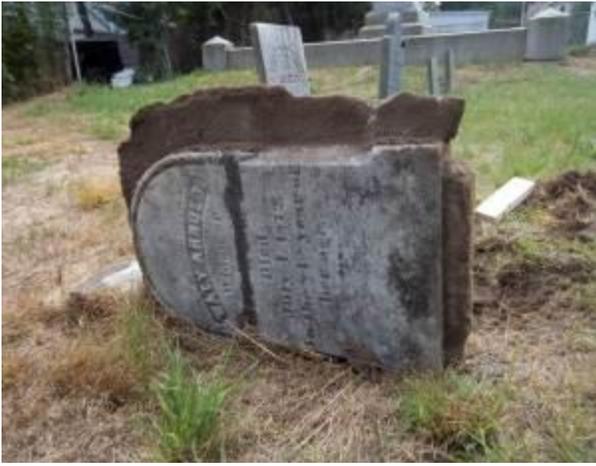
Here we have ... This goes back to Irving's images from Massachusetts. We have when they would form something like this. Sometimes they would do this in a stone and inset it into a granite, and really that's a high-end repair, but this is more common. When they do it, just puddle it right in on the flat so they can stand it up. I mean, at least they saved the stone and oftentimes the pieces will disappear if they didn't do something. These things are historic.

Historic marble marker laid in concrete.

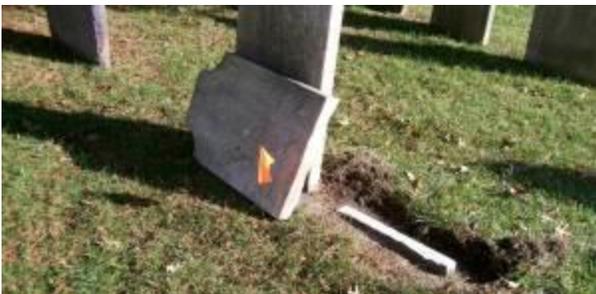
Here's another one. This is back ... I just showed some earlier shots. This is Ring Swamp Cemetery in Hampton, New Hampshire. They did something pretty cool here. They decided that even if the stones were in good condition, that they would cover all the bases and stuff with concrete anyway just for fun. Luckily it was like I said, poor quality concrete, and also it had a lot of rock in it.

Examples of Common Problems Caused by Hard Cement based Repairs Puddling into wet concrete.

I found that after experimenting that I could actually just break it away without damaging the stone if I was careful. You can see there was a little chippage here, but pretty much it broke away, but the interesting thing is that there was no reason for it in the first place. It had a full base on it and it wasn't even broken. It's like, what are they thinking? It's hard to know.

Here's another one. Yeah, same cemetery. You can see the concrete collar technique. Big chunks of ... It's a batch mix and then big chunks or rocks, gravel mixed in. That's why it was able to be broken away as well as it was. I found that it was actually much safer. In the case of stones like this, what I could do is just cartwheel them out of the hole first, and then to get this off, a lot of times it's better to hit it up into the mass of it because it's much less likely you'll break off the bottom because there's more surface area up here and it's much stronger that way, so that's what I did. There's some of my workmanship. The town was nice enough to

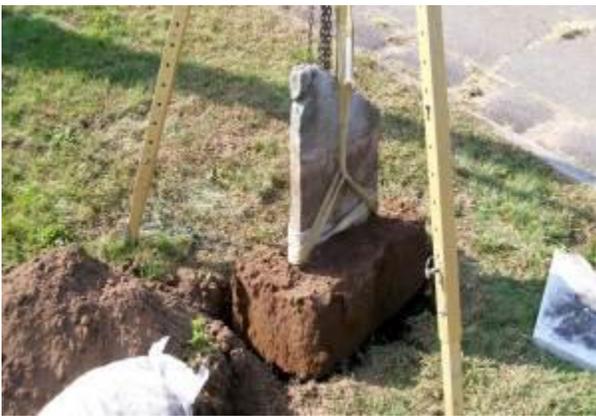
Lifting a broken marble marker cast in concrete

I get there and I see this. Well of course it's in Portland cement. What else is new? Everything's in Portland cement. I'm like, "Okay that's all right." I have a lot of ability to move things. My first thing is what I'm going to do. I see this, I'm like I'm going to pry this thing out of the ground. Where this concrete is connected to I'm going to make a new, cast a new base, just underground with a socket, and then I'm going to reset this thing.

I decided that I wasn't going to move it, so I broke away that top piece of the tablet. Just to back up a little, you can't join something to this. There's too much loss, it's really sugary, it's all broken down. You can see what happen actually, when you smack it with the hammer it just breaks up and it just turns into powder, a lot of it because it has no strength.

Then what I did is I made a form ... I thought I had a picture of it, and somehow I missed one. Yeah that's okay. I built a form and I had enough stuff with me to do this. I always have all cordless tools and everything. I was short, so that's why there's a scab here holding two pieces together. I had just enough material with me to get this thing built. What you see in the center here is that, that is foam. High density rigid foam, like Styrofoam installation, two inch thick.

Then it was broken at an angle, and depending ... I mean if it's just a little bit you can just shim it up a little, but it's better to square it off. Again, I use cordless tools a lot, and so I scored it and then I cut it with a diamond blade on a grinder. This is showing the whole process. There's the fresh cut that's nice and square. Then I tore the foam out. Remember this is all one day. You've got to use fast set concrete.
