Source – NCPTT 7/2014

## Abrasive Cleaning of Grave Markers

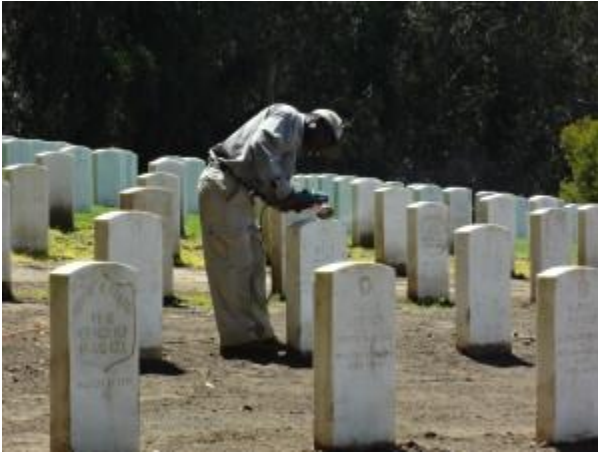
This image show the inappropriate use of a wire brush on a power drill to alter the surface of a grave marker.

NCPTT does not advocate the use of power tools to clean headstones. The use of such tools can abrade and remove granules from weathered marble and limestone. We do not advocate grinding, re-lettering, or polishing headstones as this alters the original surface of the grave marker. The company that makes Nyalox brushes compares their performance to wire brushes, which are much too harsh for a stone surface. Would you use a Nyalox brush on a power drill to clean the surface of your automobile? If not, then you would not use it to clean a grave marker.

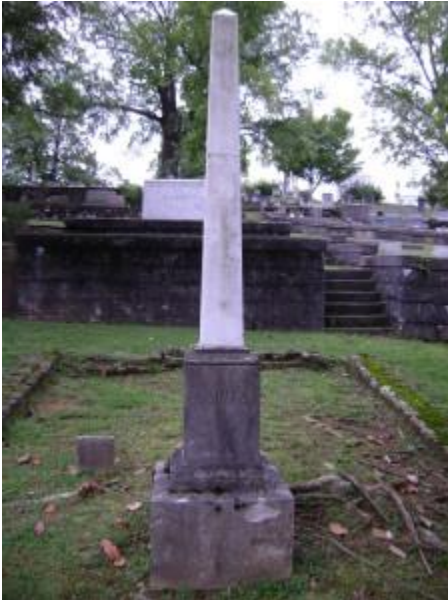
From a distance the obelisk appears normal after cleaning

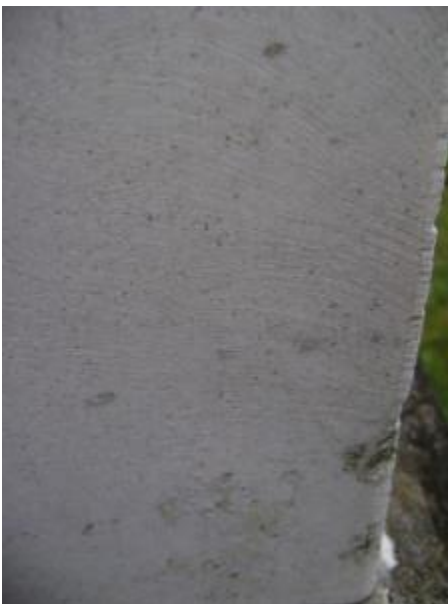
Up close to the cleaned obelisk, serious surface alterations can be seen.
